Comparative study on field collected samples of aged silicon rubber composite coatings for high voltage insulators

Keywords: HV insulators, RTV SIR coatings, aging, characterization.

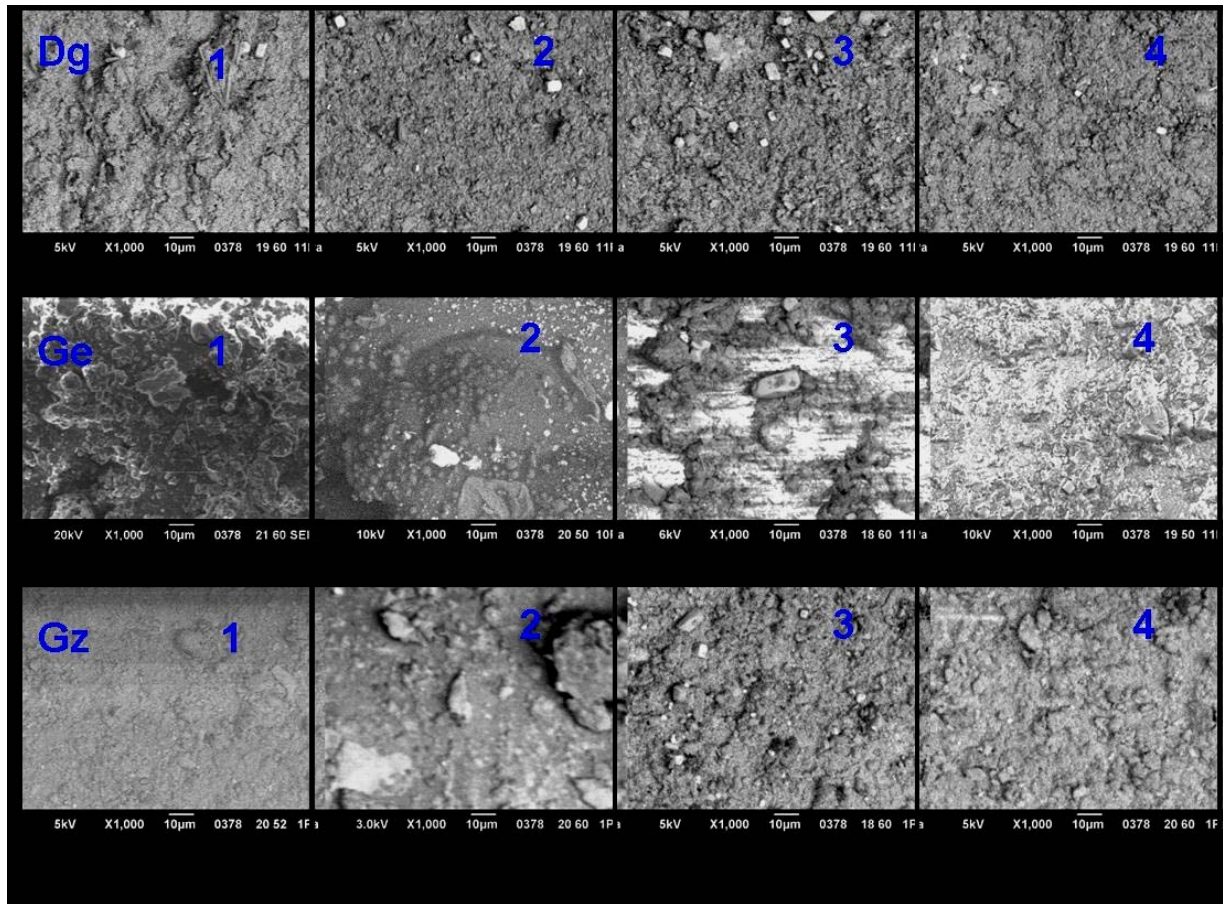
Figure 4. SEM images for the various field samples.

From figure 4 one can conclude that the oldest samples show modified morphology. They have a “dusty” appearance and obvious cracks. Cubic crystalline contaminants are present onto the surface. According to the spatial position onto the insulator body, it seems that position 2 is the less degraded, position 3 is strongly contaminated while position 1 seems the most degraded.

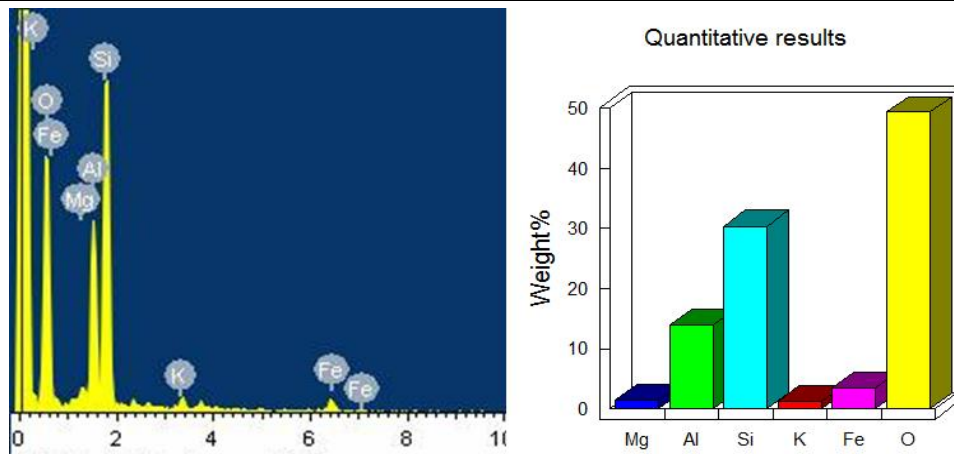
Figure 5. EDX spectrum of Dg1 sample and elemental weight distribution.

EDX analysis showed a very large variation of carbon content in the samples as well as presence of various contaminants onto surface. The most common contaminants are NaCl (associated with the presence of sea water in the atmosphere), S and metals as K, Ti, Fe, V, Mg, Ca associated with the presence of strong corona discharges. An example of EDX results for the sample Dg1 are shown in Figures 5 and 6.

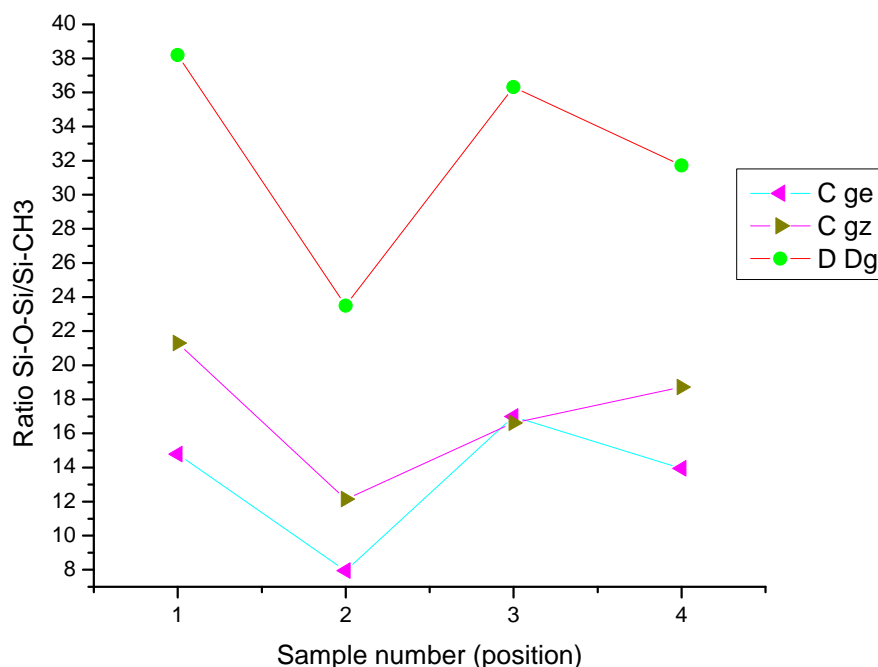
Figure 7. Graphical representations of the normalized areas ratios for Si-O-Si and Si-CH₃ bonds as a function of spatial position.

It is obvious from the above that the variation of normalized areas ratios values fulfils the initial assumptions regarding the normalized areas ratios for Si-O-Si and Si-CH₃ bonds as a measure of SIR HTV degradation and confirms the SEM observations. The oldest and most damaged sample Dg has the largest corresponding report values. Position 2 onto insulator has in all samples series the lowest local value while position 1 corresponds to highest degradation degree.
