# Comparative study on field collected samples of aged silicon rubber composite coatings for high voltage insulators

**Keywords:** HV insulators, RTV SIR coatings, aging, characterization.

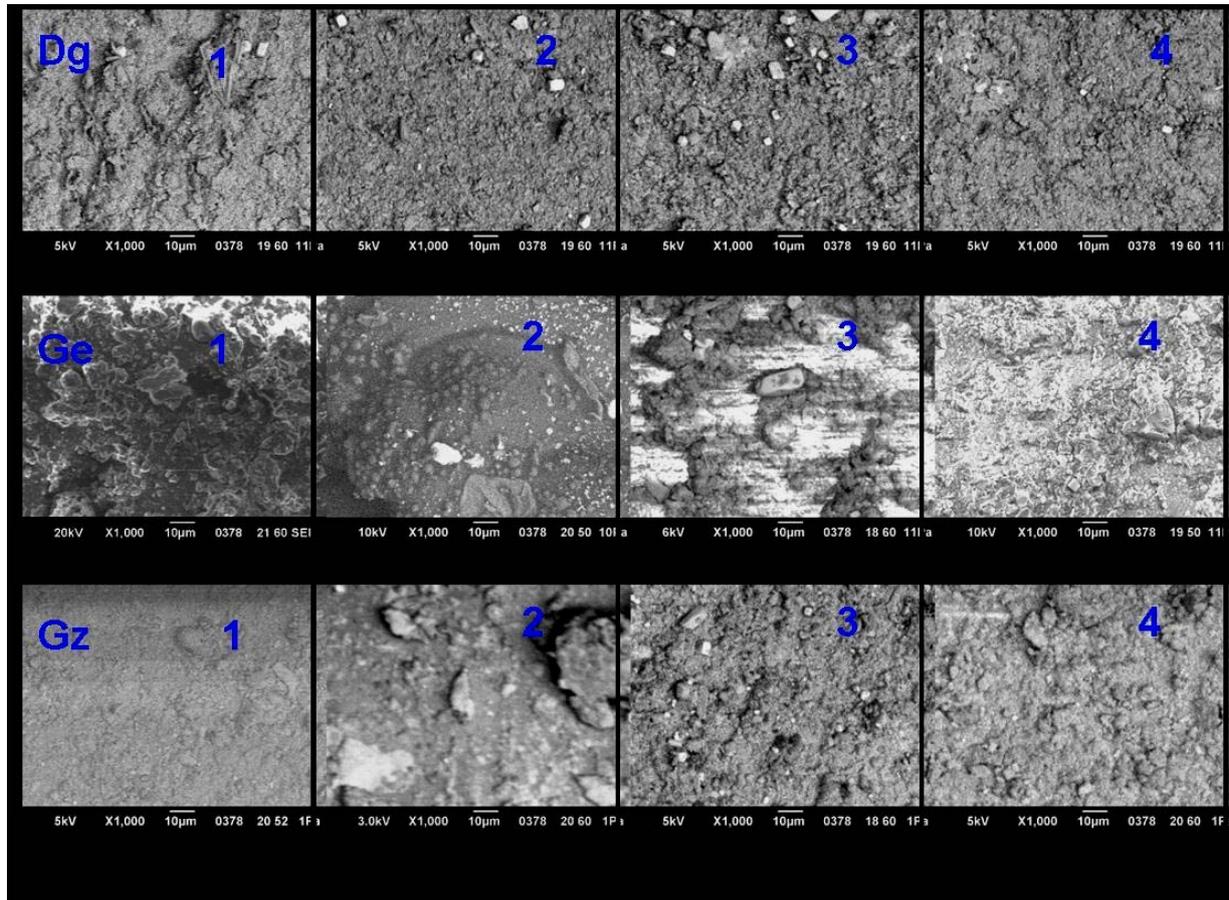
**Figure 4.** SEM images for the various field samples.

From figure 4 one can conclude that the oldest samples show modified morphology. They have a “dusty” appearance and obvious cracks. Cubic crystalline contaminants are present onto the surface. According to the spatial position onto the insulator body, it seems that position 2 is the less degraded, position 3 is strongly contaminated while position 1 seems the most degraded.

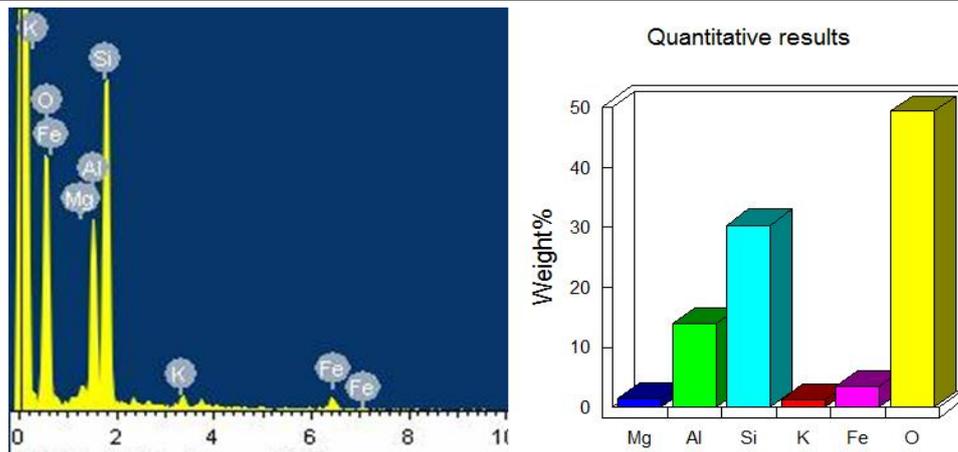
**Figure 5.** EDX spectrum of Dg1 sample and elemental weight distribution.

EDX analysis showed a very large variation of carbon content in the samples as well as presence of various contaminants onto surface. The most common contaminants are NaCl (associated with the presence of sea water in the atmosphere), S and metals as K, Ti, Fe, V, Mg, Ca associated with the presence of strong corona discharges. An example of EDX results for the sample Dg1 are shown in Figures 5 and 6.

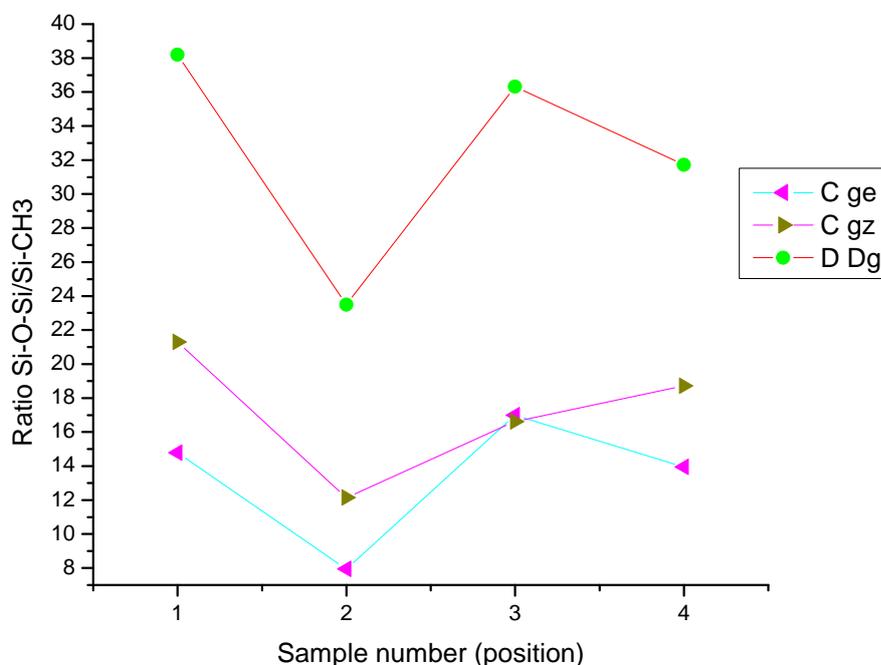
**Figure 7.** Graphical representations of the normalized areas ratios for Si-O-Si and Si-CH<sub>3</sub> bonds as a function of spatial position.

It is obvious from the above that the variation of normalized areas ratios values fulfils the initial assumptions regarding the normalized areas ratios for Si-O-Si and Si-CH<sub>3</sub> bonds as a measure of SIR HTV degradation and confirms the SEM observations. The oldest and most damaged sample Dg has the largest corresponding report values. Position 2 onto insulator has in all samples series the lowest local value while position 1 corresponds to highest degradation degree.
