ARCHIVES OF MECHANICAL TECHNOLOGY AND MATERIALS

# The influence of sodium chlorides fog on corrosion resistance of heat exchangers used in automotive

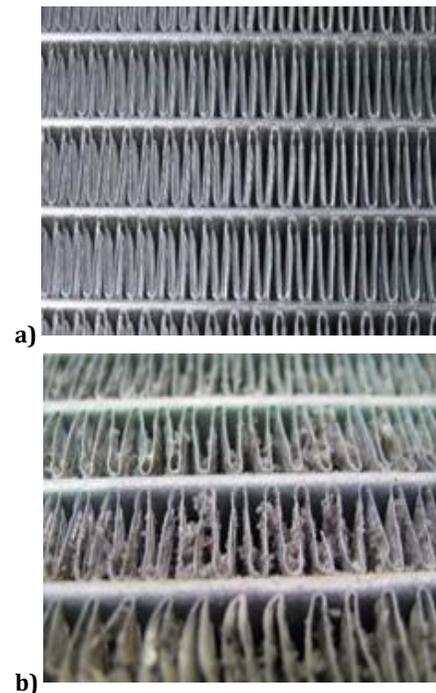
Figure 1 shows the heat exchangers parts after the process of manufacturing and after the test in the salt chamber. The second one contains the residues of salt particles in between the tapes which block flow of air through the blinds of the tape what worsen the heat exchange between hot cooling fluid and the environment. On the basis of the visual evaluation no damage of the cooling fluid tube in the heat exchanger was observed, which results in leaks in the engine cooling system or air-conditioning.

**Fig. 1. The view of heat exchanger parts: a) after manufacturing, b) after test in the salt chamber**

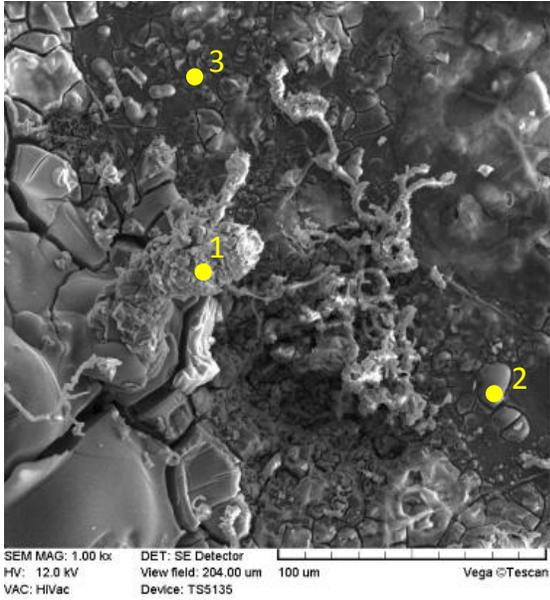
The surface of the heat exchanger after the corrosion resistance test is shown in Figure 2. No corrosion pits were observed in the analyzed area. The presence of crystallized salt layer which closely adheres to the heat exchanger material was identified. The performed chemical compositions test (fig. 3) in these area showed mainly the presence of oxygen, chlorine, potassium and aluminum as well as fluoride and sodium. On this basis, the crystallized particles were found to be probably sodium and potassium chloride. No damage of passive layer of aluminum oxide on the surface of aluminum alloy was observed, which confirms the presence of oxygen.

Fig. 2. SEM image of the heat exchanger surface after the salt spray test with the marking of the EDS microanalysis location

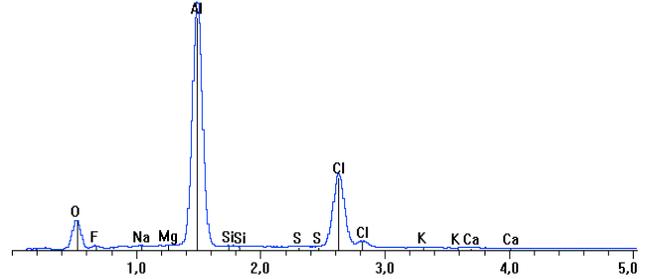
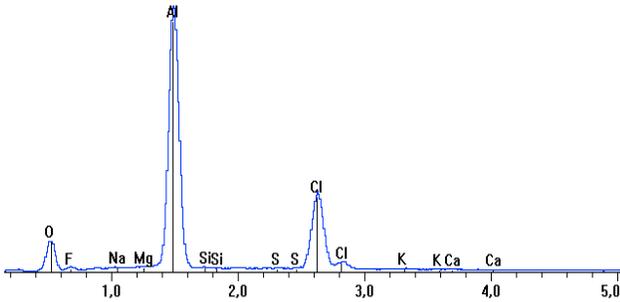
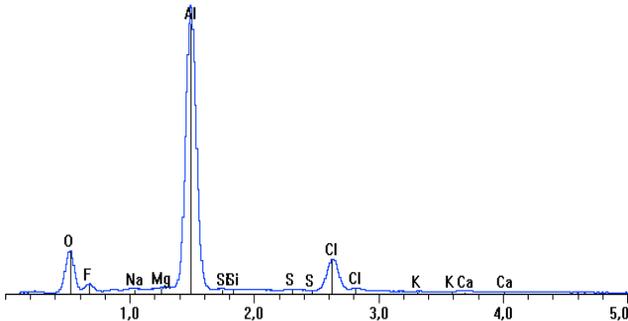
Element	Line	Wt%	At%
O	KA1	31,69	44,30
Al	KA1	52,45	43,50
Cl	KA1	10,74	6,77
Na	KA1	0,39	0,37
K	KA1	0,00	0,00
F	KA1	3,58	4,21
Mg	KA1	0,34	0,32
S	KA1	0,23	0,16
Ca	KA1	0,44	0,24
Si	KA1	0,15	0,12
<b>Total</b>		<b>100,00</b>	<b>100,00</b>

Element	Line	Wt%	At%
O	KA1	26,61	39,76
Al	KA1	46,24	40,99
Cl	KA1	24,60	16,59
Na	KA1	0,35	0,37
K	KA1	0,27	0,17
F	KA1	1,23	1,55
Mg	KA1	0,32	0,32
S	KA1	0,07	0,05
Ca	KA1	0,18	0,11
Si	KA1	0,13	0,11
<b>Total</b>		<b>100,00</b>	<b>100,00</b>

Fig. 3. The results of EDS microanalysis after the corrosion test in the salt chamber: a) point 1, b) point 2, c) point 3

Element	Line	Wt%	At%
O	KA1	26,20	39,25
Al	KA1	46,80	41,59
Cl	KA1	24,53	16,58
Na	KA1	0,31	0,32
K	KA1	0,26	0,16
F	KA1	1,19	1,50
Mg	KA1	0,31	0,30
S	KA1	0,10	0,07
Ca	KA1	0,14	0,08
Si	KA1	0,16	0,14
<b>Total</b>		<b>100,00</b>	<b>100,00</b>

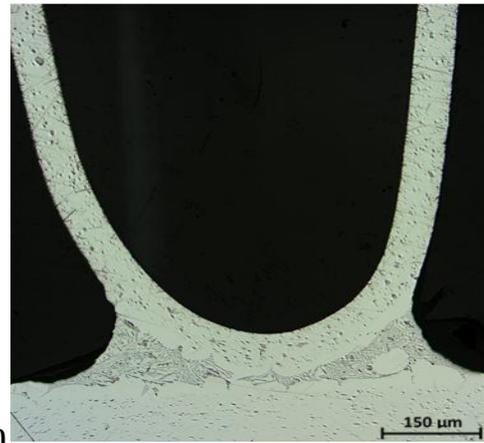
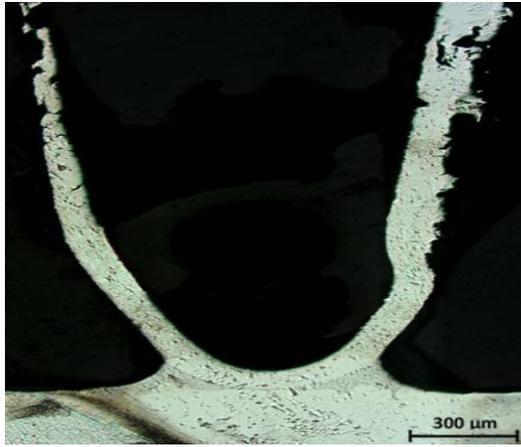
After the initial observation of the heat exchanger surface after the test in the salt chamber, light microscopy images were made in the areas of brazed joint (fig. 4). Numerous deep corrosion pits were identified in the tape which increases the surface of heat exchange. No damage of cooling medium tube was observed. Corrosion changes in the tape area worsen the heat exchange function but did not cause serious leakage of cooling fluid.

**b)** Fig. 4. Light microscopy images of the brazed joint area: a) after manufacturing, b) after test in the salt chamber

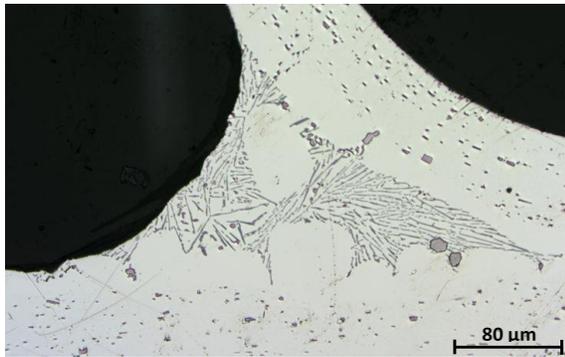
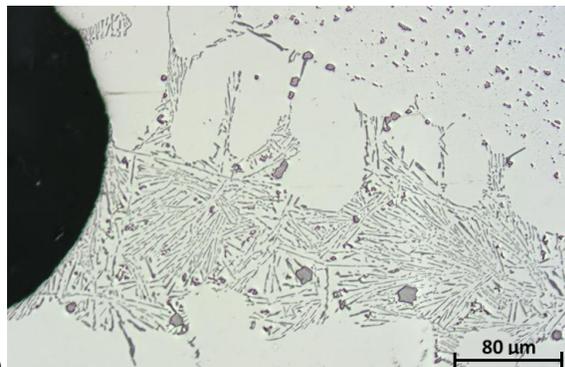
Figure 5. shows the images of brazed joint (cooling fluid tube – tape which increases the surface of heat exchange) after brazing and after the test in the salt chamber, obtained by the light microscopy method. The identified structural components in the brazed material area are:

- solid silicon solution in aluminum Al,
- coarse, coniferous Al-Si eutectic,
- formation of intermetallic phases, mainly Al-(Fe, Mn)-Si.

No corrosion damage was observed in the brazed joint area. Thus, the formation of potential leakiness in this area under the influence of the corrosive environment of the salt fog appearing during exploitation of heat exchangers is unlikely.

Fig. 5. The view of microstructure of brazed joint in the automotive heat exchanger: a) after manufacturing, b) after test in the salt chamber
