SOME INVESTIGATIONS PERFORMED FOR THE BRIDGE OVER JIU AT ANINOASA

Abstract

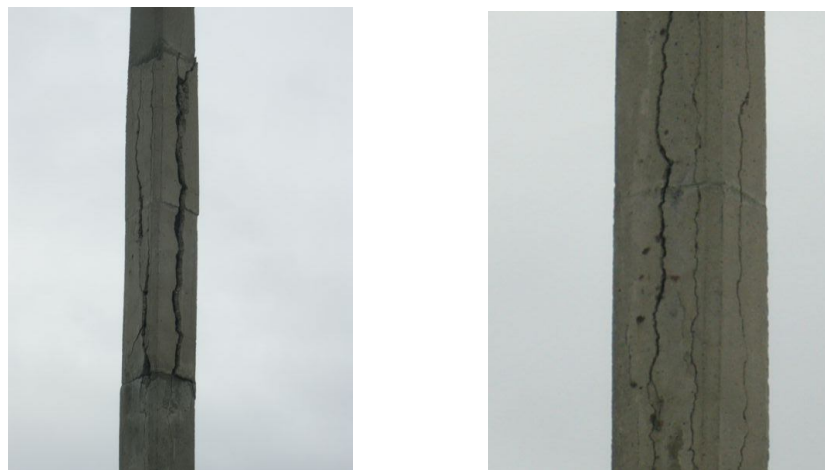
Figure 2. Cracks at some of the bridge concrete hangers

Following a technical appraisal finalized in 2005 by "APECC" from Timișoara, many damages of the carrying structure of the bridge, but also of the roadway layers and of the bridge equipments (bearing devices, outflows, handrails, guiding guardrails) were observed. From all these damages, the most severe and which can affect the bridge safety, are the cracks observed at cross girders near to the Gerber snouts, but also at eleven hangers, seven on the right side and four on the left side of the bridge. At some hangers, the concrete which protects the reinforcing bars is seriously damaged, the cracks are vertical, their opening reaches 30 mm and they are developed on 25-100% from the length (Figura 2).

For this reasons, it was necessary to perform new analyses of the bridge structure, in order to find out the causes of these problems and to establish the measures and technology for the bridge strengthening. The analyses have included both numerical calculation and “in situ” tests with real trucks of the bridge structure. The numerical calculations were carried out at the “Bridges”

stresses and displacements can lead in time to the crack formation in the hangers concrete structure.

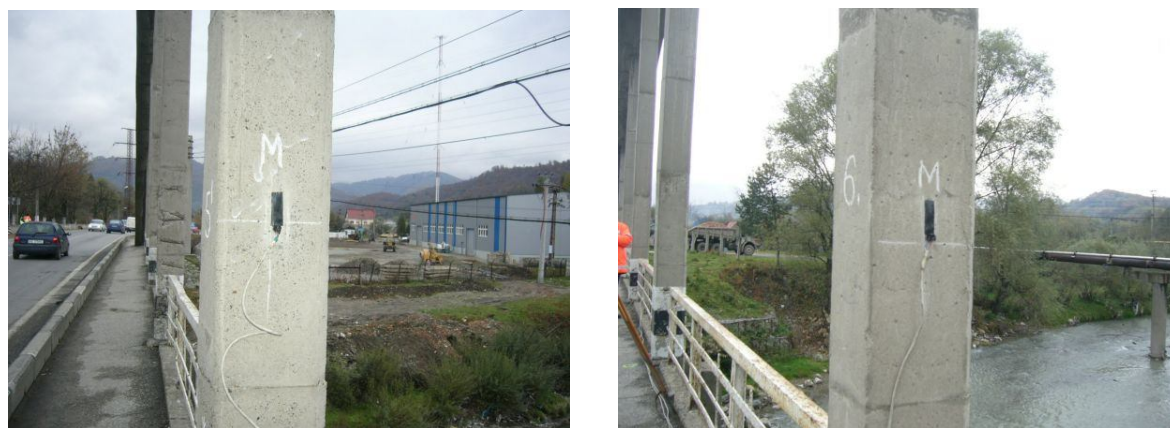
Figure 4. Electro-resistive transducers placed on the concrete hangers

For strains measurements, on four hangers - 1',5',6 and 10 (Figura 3) electro-resistive transducers type H350 (Huggenberger measurement points) were applied (Figura 4). The vertical displacements of arches and bridge deck were measured through high precision levelling using a Koni 007 level device and levelling marks placed in some sections aligned with the hangers (1-1';5-5';10-10').

In Table 2 are given, for each position of the test convoys, the measured values of the strains in the hangers where electro-resistive transducers are placed (see Chapter 2).

From table 2 it can be seen that in some hangers, for particular positions of vehicles on the deck, it is possible that some hangers are in tension, but considering also the self weight of the structure which has a high value, it is obvious that the hangers are compressed.
