Comparative study on field collected samples of aged silicon rubber composite coatings for high voltage insulators

Keywords: HV insulators, RTV SIR coatings, aging, characterization.

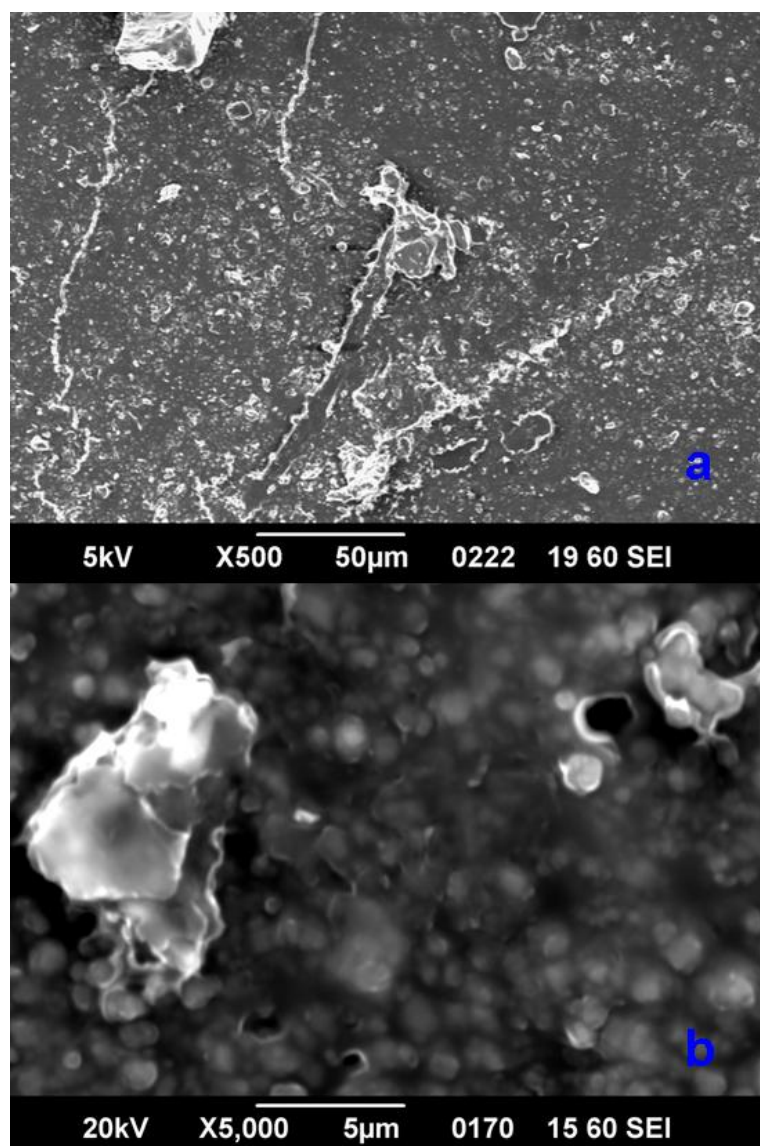
Reference sample: Figure 1 presents surface morphology of a virgin SIR HTV sample at two different magnifications and electron acceleration voltages. Higher magnification reveals the filler material distribution in the silicon rubber matrix.

Figure 1. LV-SEM image of reference SIR sample a. general view ($\times 500$ at low acceleration voltage 5kV) b. close up evidencing the filler material ($\times 5000$, 20kV).

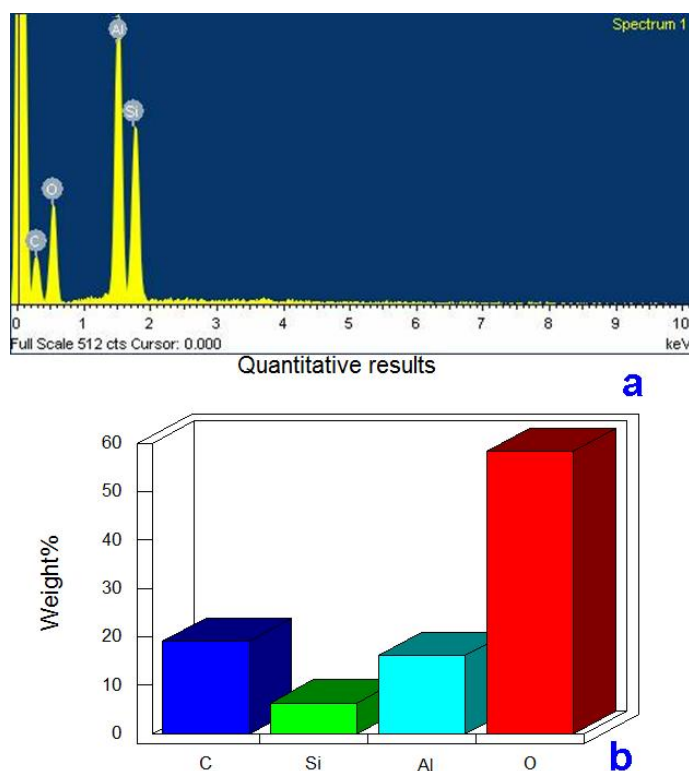
Compositional characterization of SIR sample shows the presence of C, Si, Al and O elements in the proportions presented in Figure 2b. A characteristic EDX spectrum corresponding to this sample is presented in Figure 2a.

Figure 2. Compositional characterization of SIR sample a. EDX spectrum; b. elemental composition (weight %).

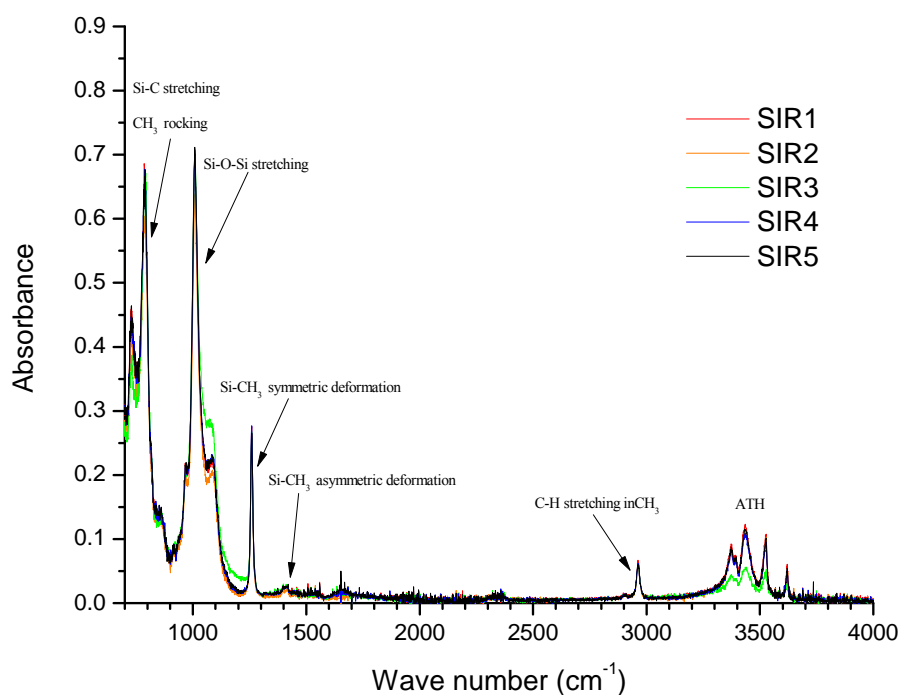
Figure 3. ATR FT-IR spectra corresponding to virgin SIR HTV sample and four artificially aged samples.

Since the area of the peaks is directly related to the concentration of a group in a given material the ratio of two peaks is equal with the ratio of the absolute quantities of the investigated molecular components. Based on this we can see how a molecular composition changes during degradation. In case the polymer is oxidizing the normalized ratio is expected to grow due to the fact that more Si-O bonds are formed while the methyl groups transform in other products. In case the backbone of the polymer brakes forming lower mass products the Si-O peak will drop thus decreasing the normalized ratio. If a sample has silica as a filling material the results are difficult to interpret since the lower mass molecules are migrating toward the surface modifying the ratio in a random fashion. Based on the above, we may assume that the SIR samples degrade by oxidation.

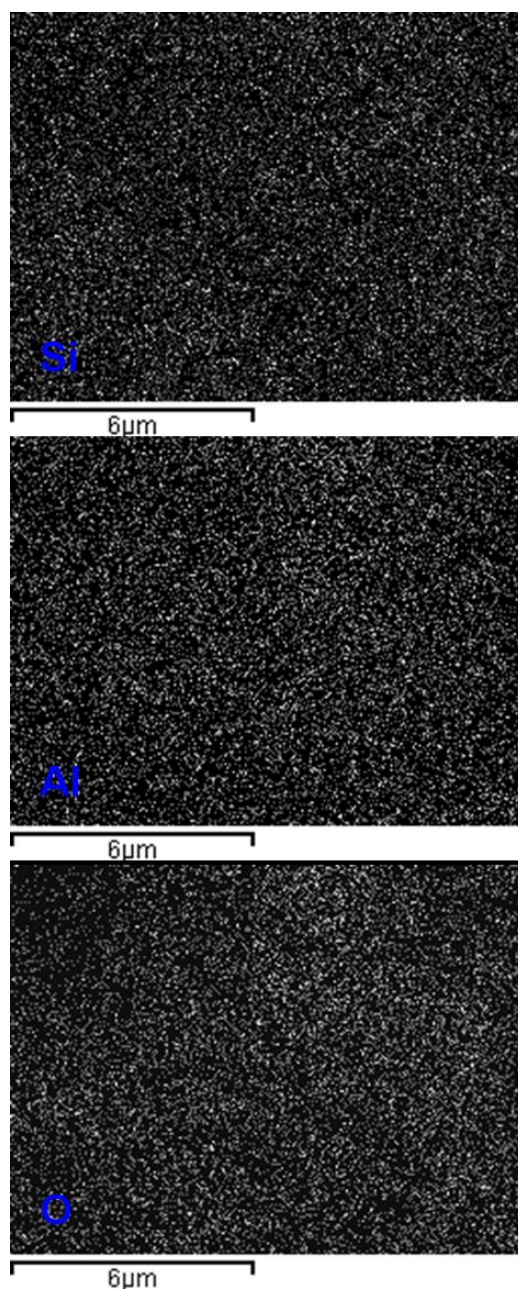
EDX analysis showed a very large variation of carbon content in the samples as well as presence of various contaminants onto surface. The most common contaminants are NaCl (associated with the presence of sea water in the atmosphere), S and metals as K, Ti, Fe, V, Mg, Ca associated with the presence of strong corona discharges. An example of EDX results for the sample Dg1 are shown in Figures 5 and 6.

Figure 6. Elemental mapping of O, Si and Al in the analyzed sample.
