# Comparative study on field collected samples of aged silicon rubber composite coatings for high voltage insulators

**Keywords:** HV insulators, RTV SIR coatings, aging, characterization.

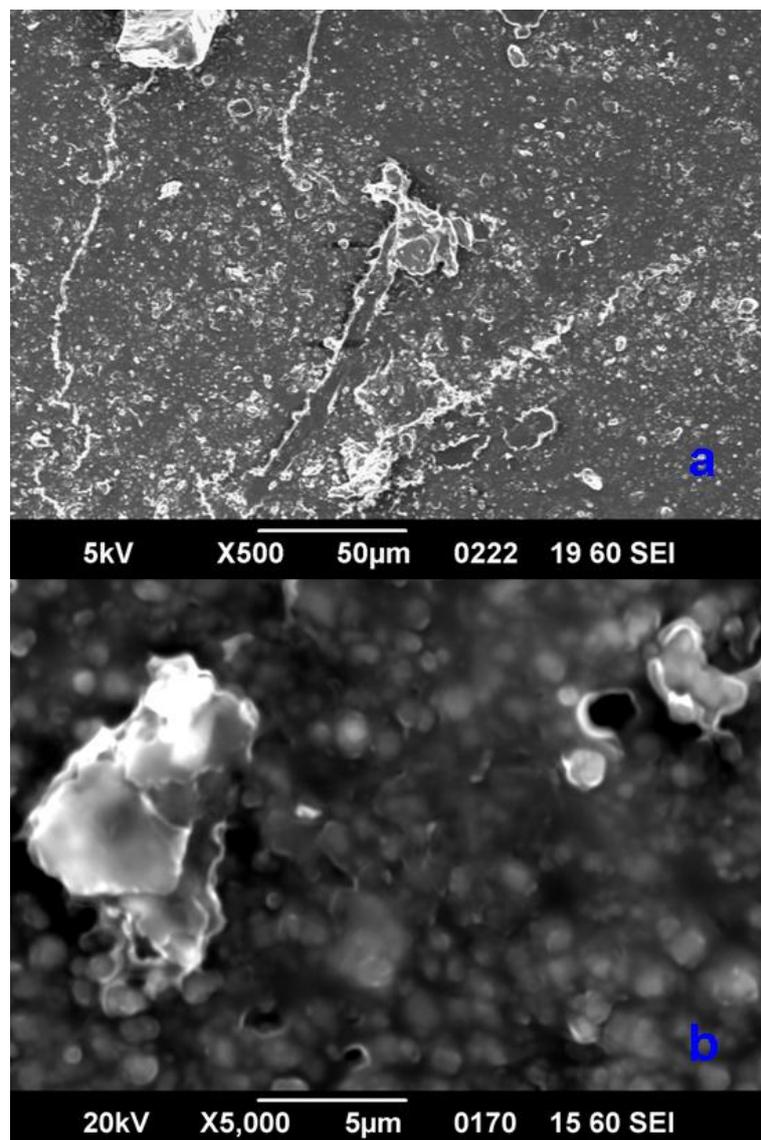
**Reference sample:** Figure 1 presents surface morphology of a virgin SIR HTV sample at two different magnifications and electron acceleration voltages. Higher magnification reveals the filler material distribution in the silicon rubber matrix.

**Figure 1.** LV-SEM image of reference SIR sample a. general view ( $\times 500$  at low acceleration voltage 5kV) b. close up evidencing the filler material ( $\times 5000$ , 20kV).

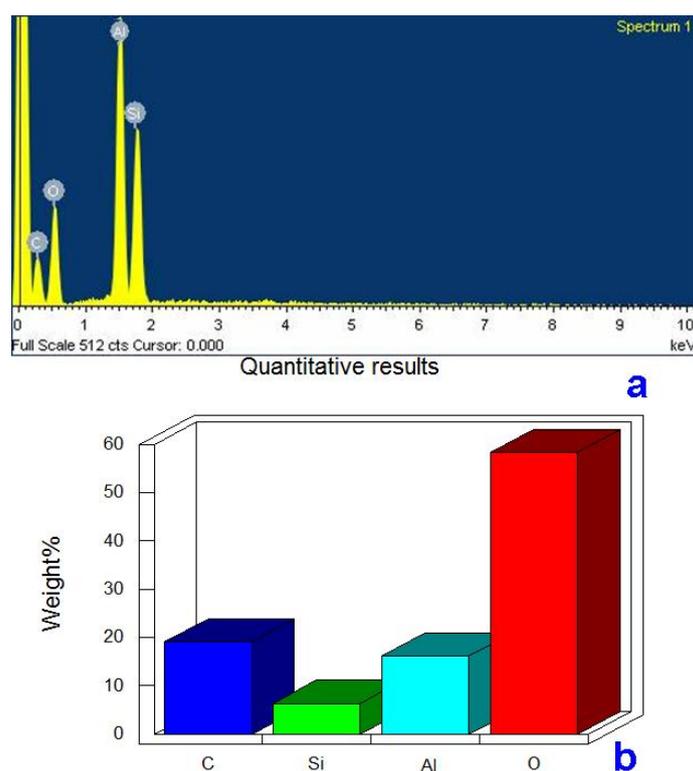
Compositional characterization of SIR sample shows the presence of C, Si, Al and O elements in the proportions presented in Figure 2b. A characteristic EDX spectrum corresponding to this sample is presented in Figure 2a.

**Figure 2.** Compositional characterization of SIR sample a. EDX spectrum; b. elemental composition (weight %).

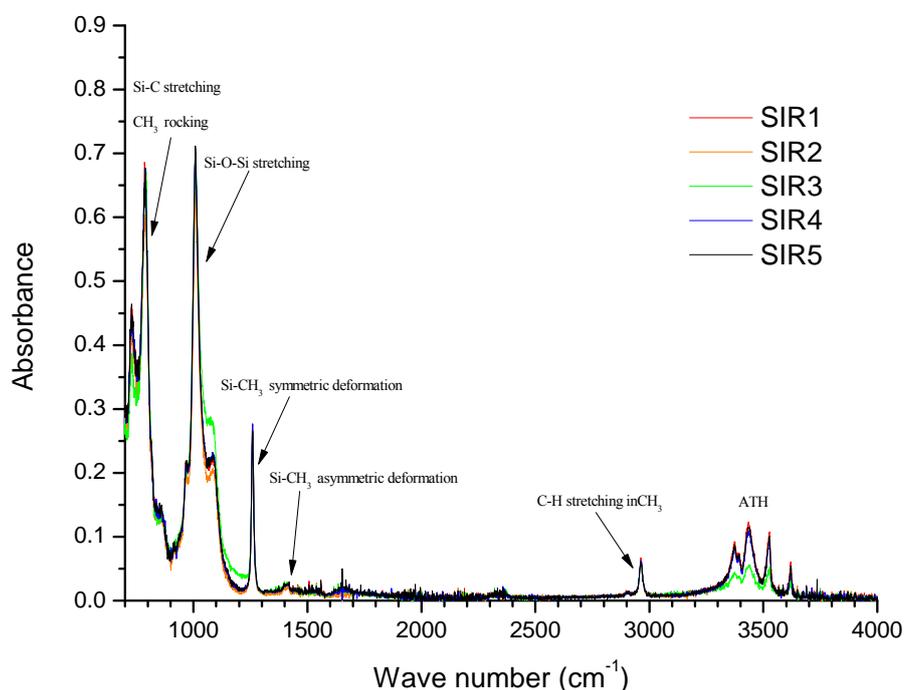
**Figure 3.** ATR FT-IR spectra corresponding to virgin SIR HTV sample and four artificially aged samples.

Since the area of the peaks is directly related to the concentration of a group in a given material the ratio of two peaks is equal with the ratio of the absolute quantities of the investigated molecular components. Based on this we can see how a molecular composition changes during degradation. In case the polymer is oxidizing the normalized ratio is expected to grow due to the fact that more Si-O bonds are formed while the methyl groups transform in other products. In case the backbone of the polymer brakes forming lower mass products the Si-O peak will drop thus decreasing the normalized ratio. If a sample has silica as a filling material the results are difficult to interpret since the lower mass molecules are migrating toward the surface modifying the ratio in a random fashion. Based on the above, we may assume that the SIR samples degrade by oxidation.
