## SOME INVESTIGATIONS PERFORMED FOR THE BRIDGE OVER JIU AT ANINOASA

The carrying structure of the bridge over the Jiu River at Aninoasa consists in two parallel concrete arches with variable height of the cross section, sustaining a concrete deck through vertical concrete hangers. In the time period passed since the bridge was erected, some structural elements shown damages. In order to establish the technical state of the bridge, a technical appraisal was performed and according to this, the most exposed elements to the risk of failure are the hangers.

The purpose of this paper is to present briefly both, the method used to test the actual bridge carrying capacity in situ and the finite element model developed for the static and dynamic analysis of the structure.

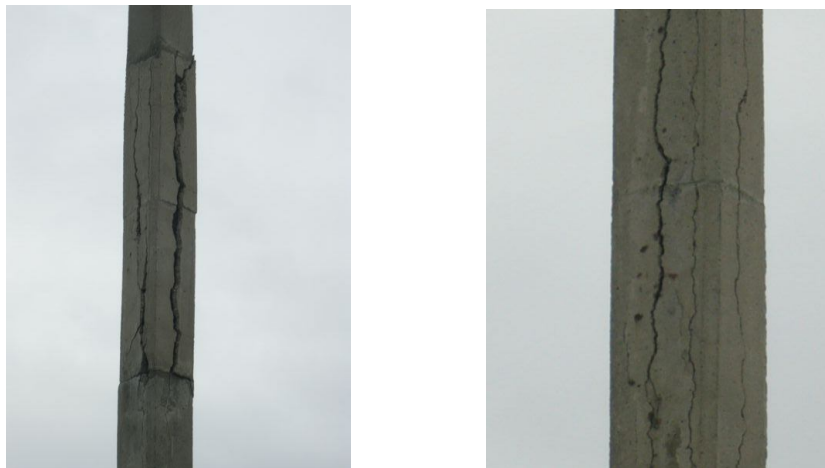
**Figure 2.** Cracks at some of the bridge concrete hangers

Following a technical appraisal finalized in 2005 by "APECC" from Timișoara, many damages of the carrying structure of the bridge, but also of the roadway layers and of the bridge equipments (bearing devices, outflows, handrails, guiding guardrails) were observed. From all these damages, the most severe and which can affect the bridge safety, are the cracks observed at cross girders near to the Gerber snouts, but also at eleven hangers, seven on the right side and four on the left side of the bridge. At some hangers, the concrete which protects the reinforcing bars is seriously damaged, the cracks are vertical, their opening reaches 30 mm and they are developed on 25-100% from the length (Figura 2).

For this reasons, it was necessary to perform new analyses of the bridge structure, in order to find out the causes of these problems and to establish the measures and technology for the bridge strengthening. The analyses have included both numerical calculation and “in situ” tests with real trucks of the bridge structure. The numerical calculations were carried out at the “Bridges”

From figures above it can be observed that the axial force in the hanger change sign and has a strong variation due to the vibrations induced by the action of the vehicle. The same tendency can be remarked also for the vertical displacement of the point at the end of the hanger. These evolutions of the

stresses and displacements can lead in time to the crack formation in the hangers concrete structure.
